Preservation Plan

THE CUMBERLAND NAIL AND IRON COMPANY OFFICE

**MAYOR AIKEN DRIVE
BRIDGETON, NJ 08302**

**WATSON & HENRY ASSOCIATES
Bridgeton, New Jersey
Project 10-010**

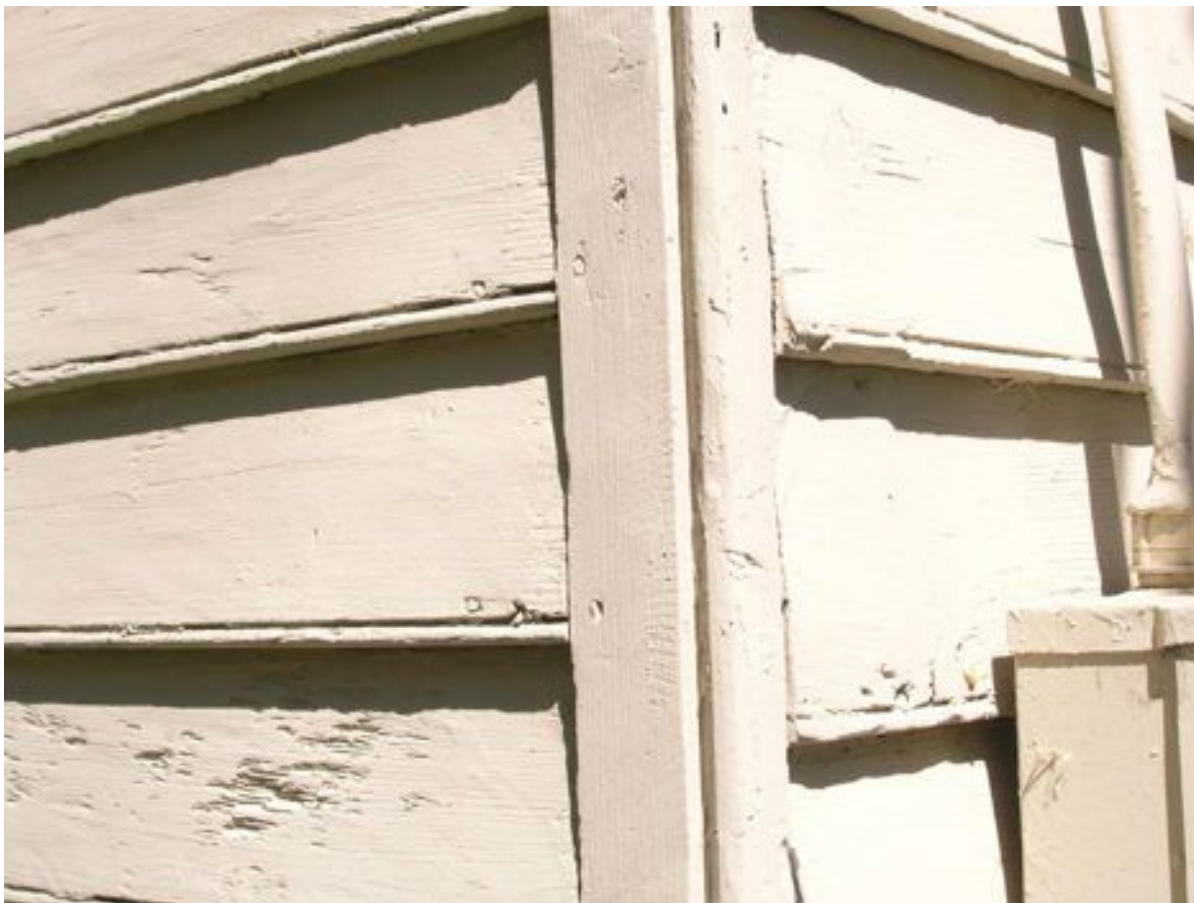
Figure 45

Cornerboard and beaded weatherboards, showing damage done through inappropriate paint removal.

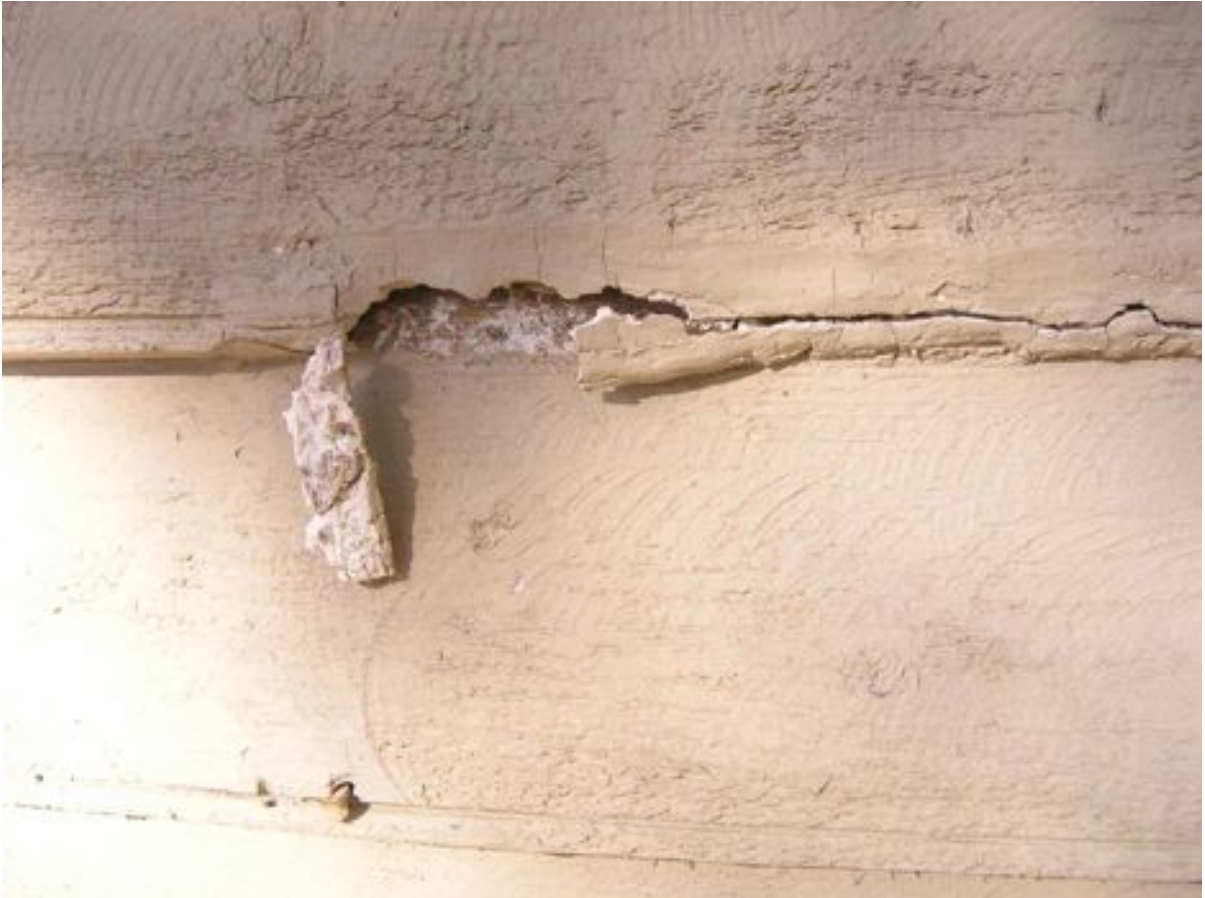
Figure 49

Repair to weatherboard made with cementitious material, now failing.

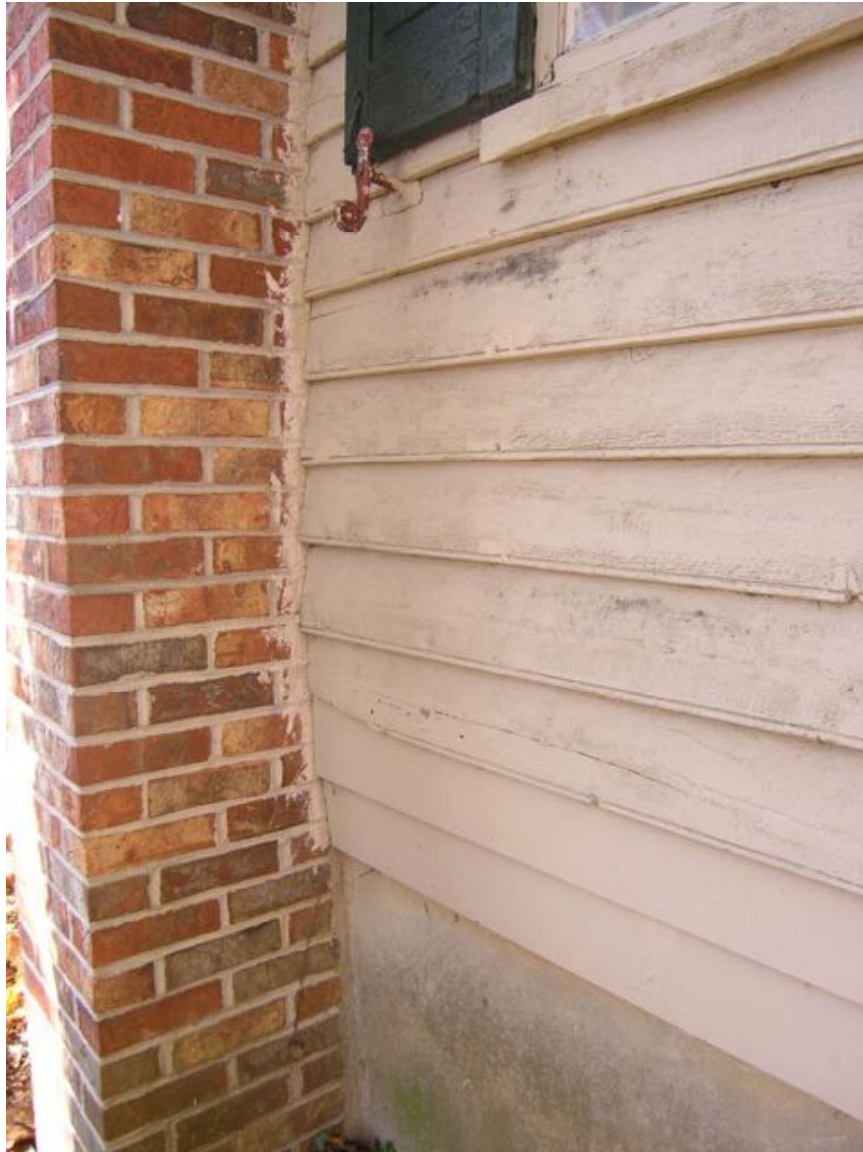
Figure 50

Bulge in cladding on east side, indicating deterioration and compression of framing.

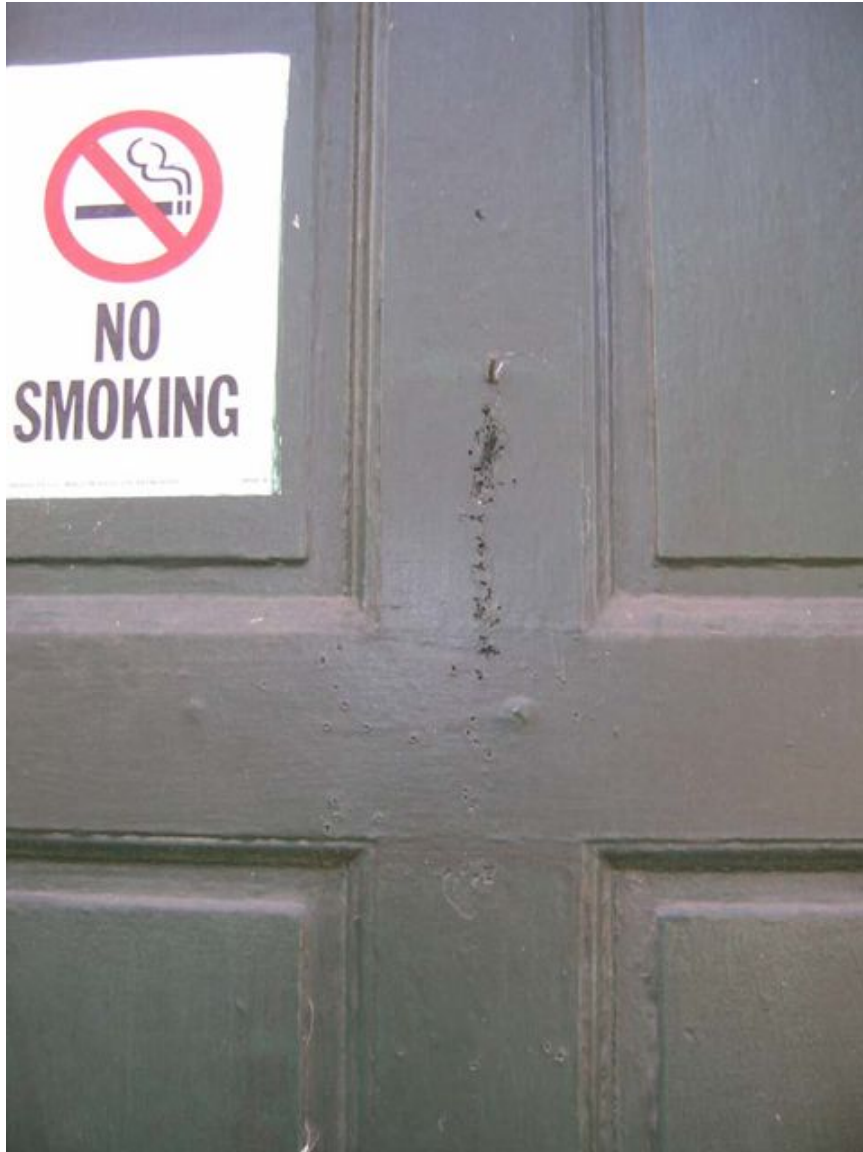
Figure 52

Original entrance door, showing evidence of notices tacked to door during occupancy by the Cumberland Nail and Iron Company, and inappropriate No Smoking sign.

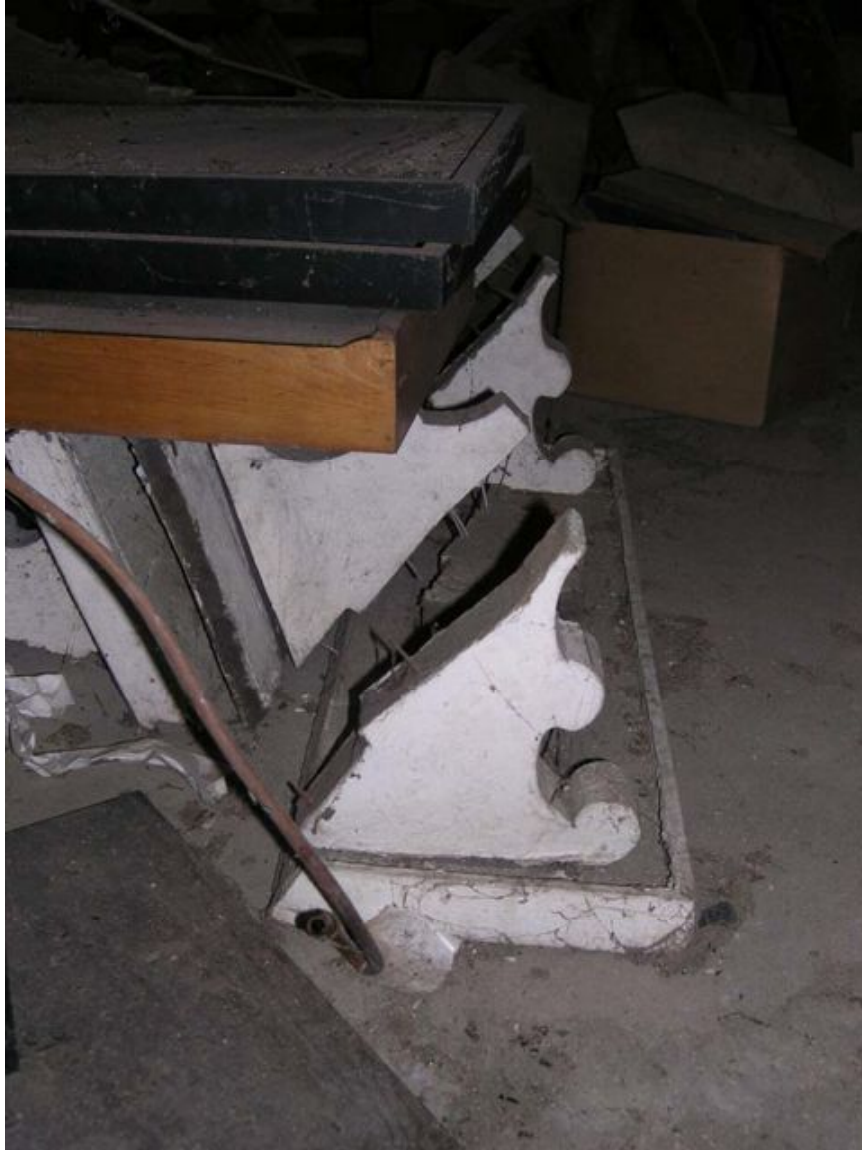
Figure 53

Window hoods stored in basement.

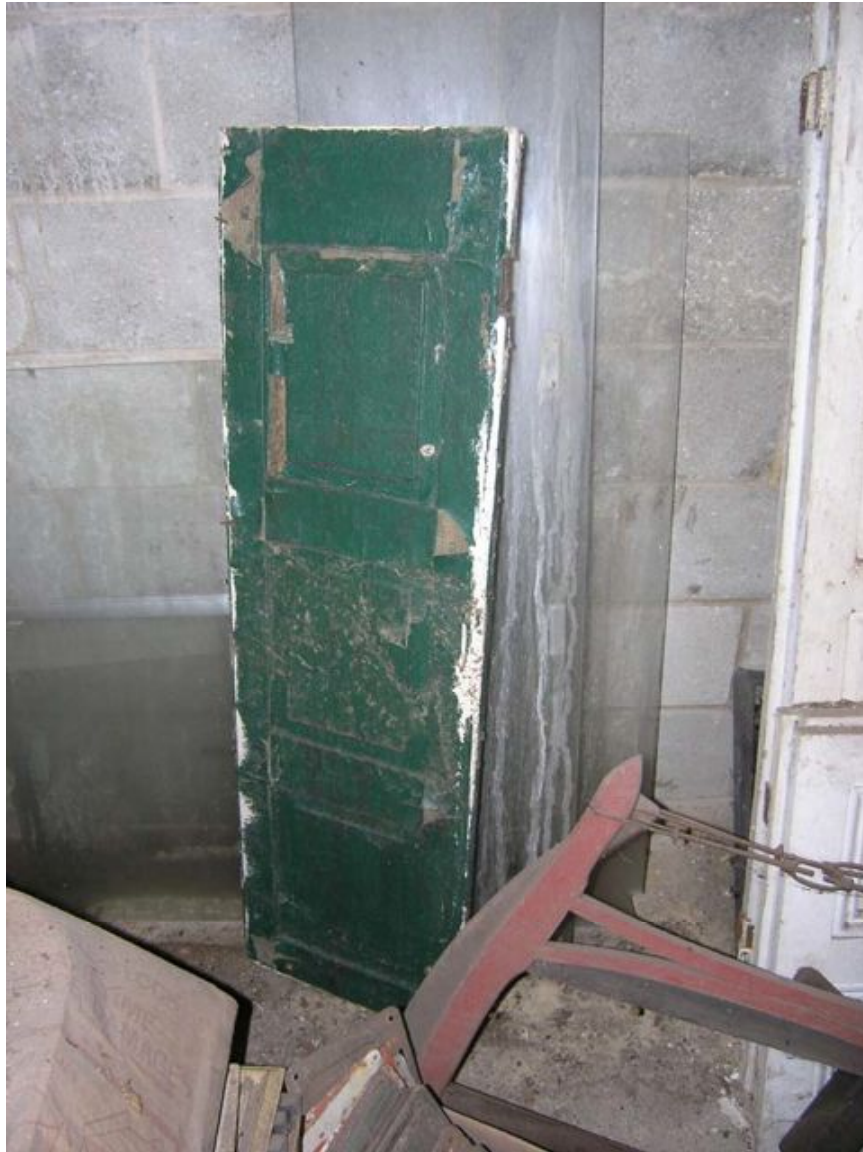
Figure 54

Shutter missing from east façade stored in basement.

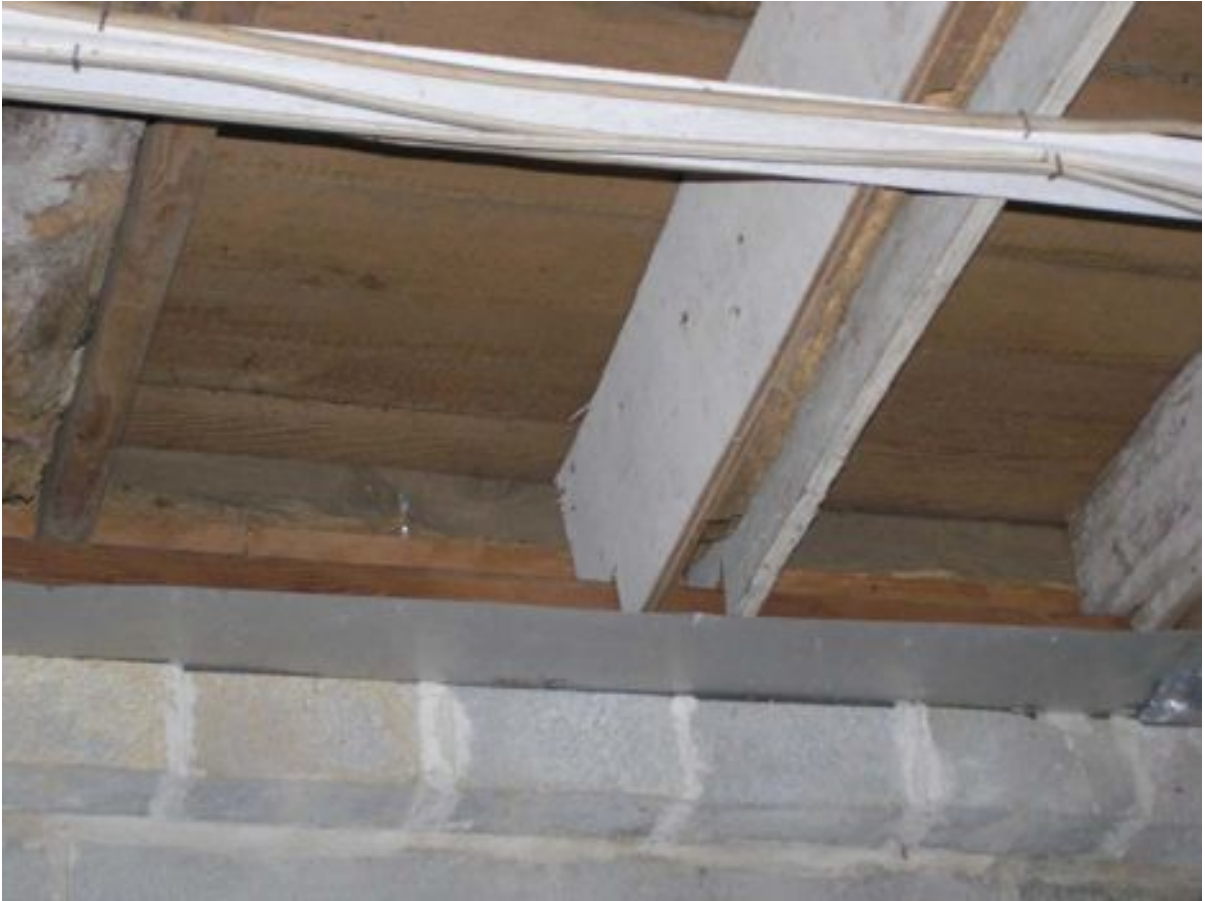
Figure 67

Non-engineered sistering of joist with plywood.

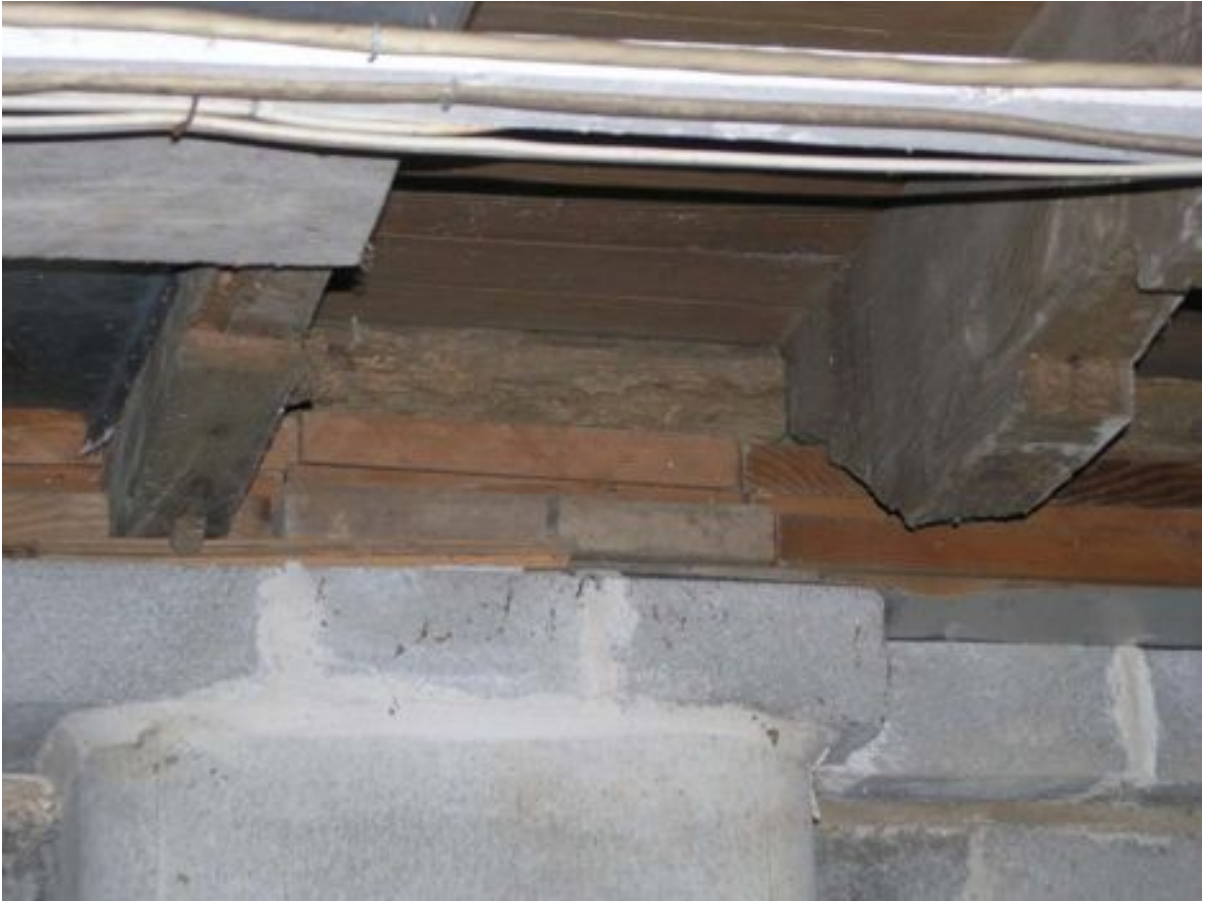
Figure 68

West sill of First Build (south) section showing previous repair interventions.

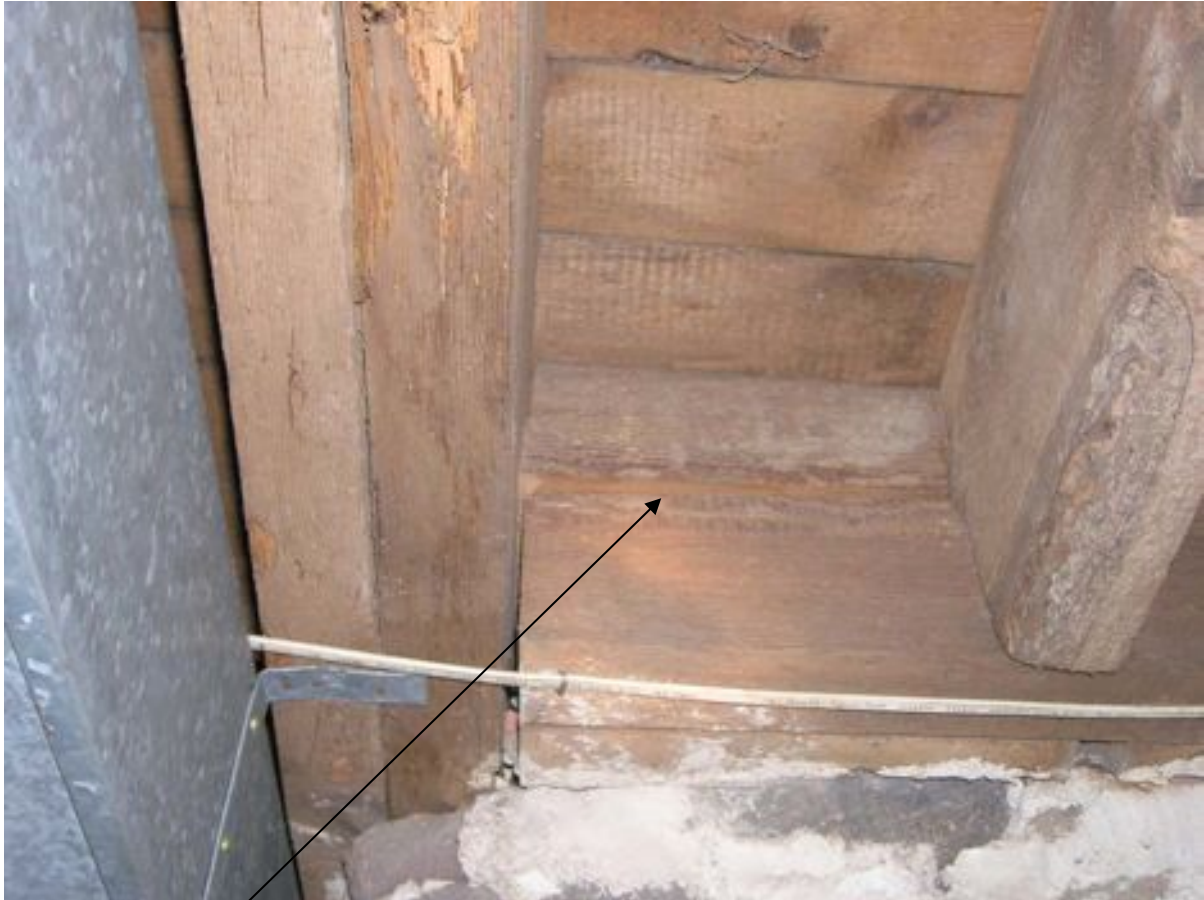
Figure 69

Split

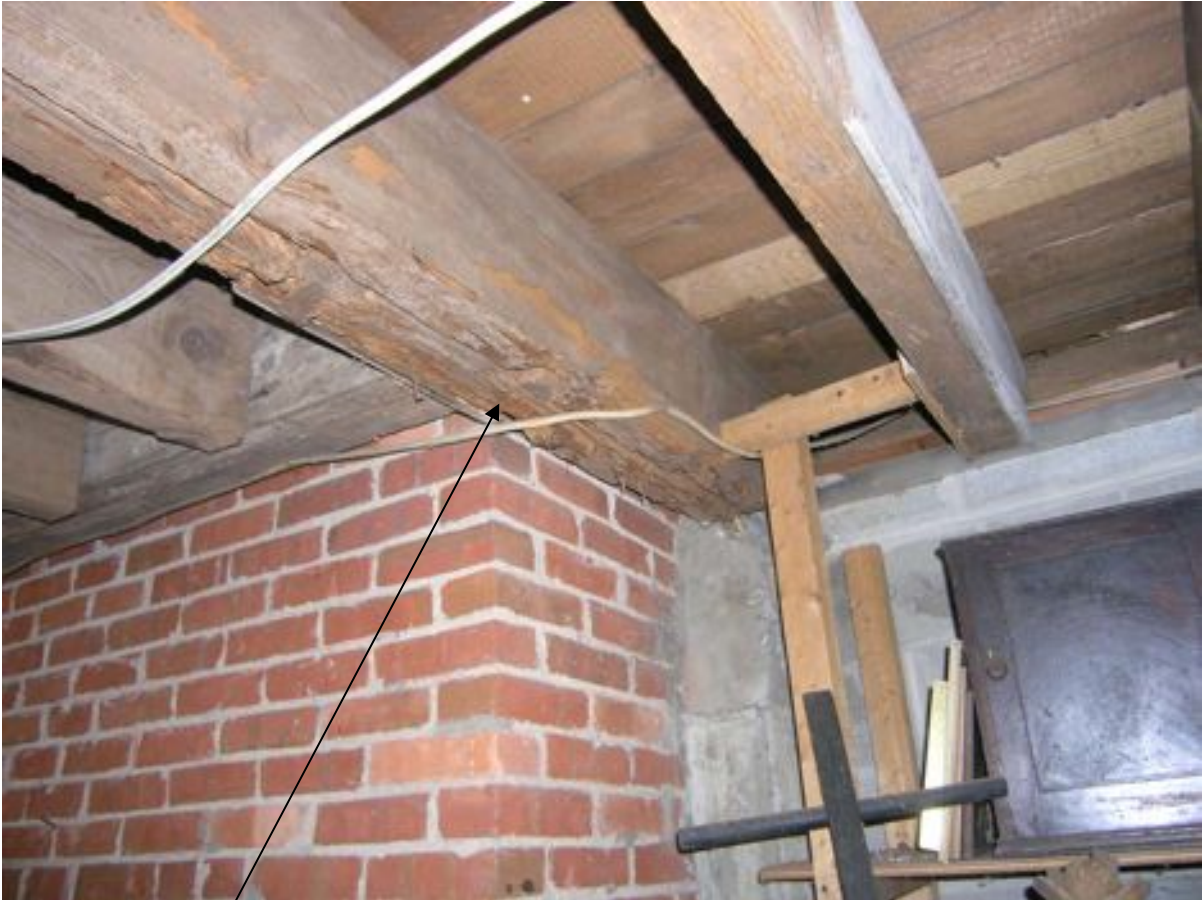
Figure 70

Deterioration

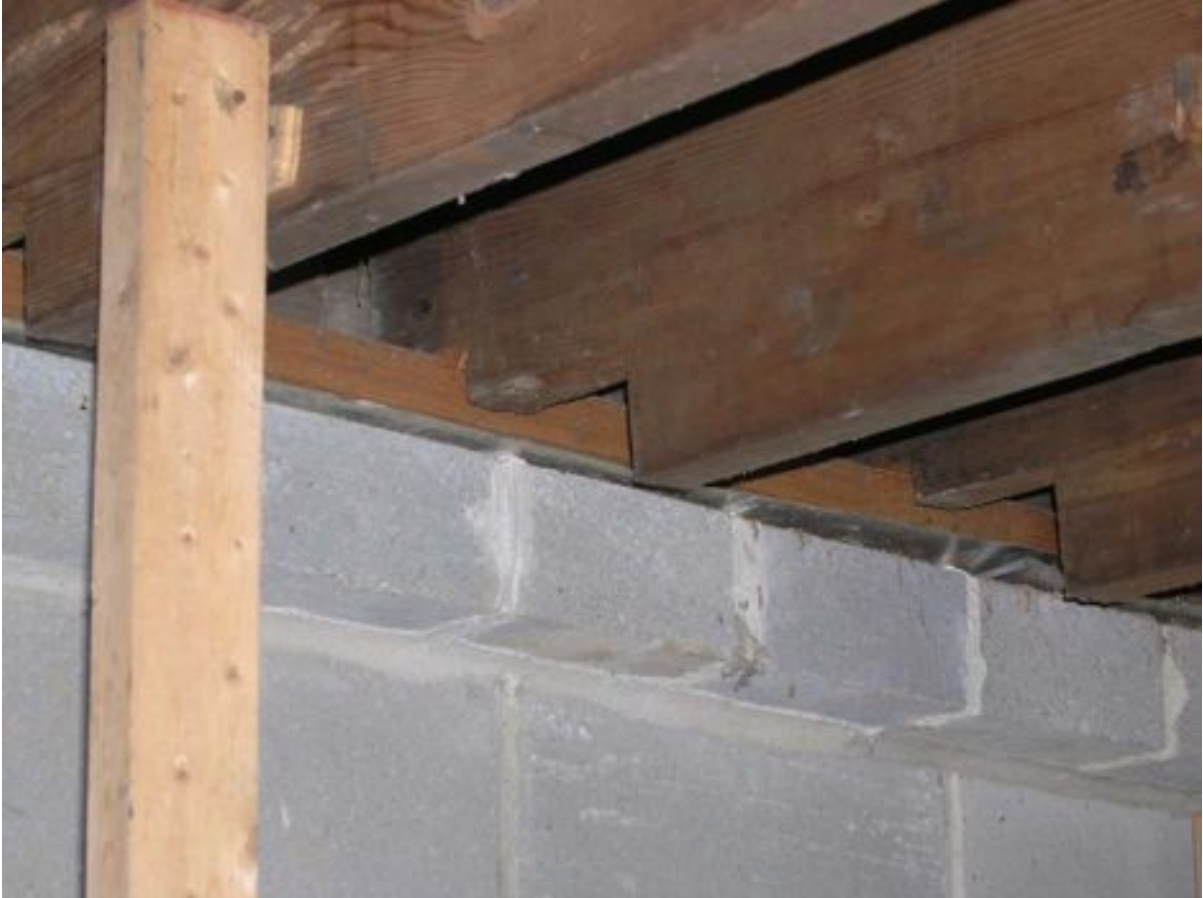
Figure 71

Double notched joists in basement under Third Build (north) section.

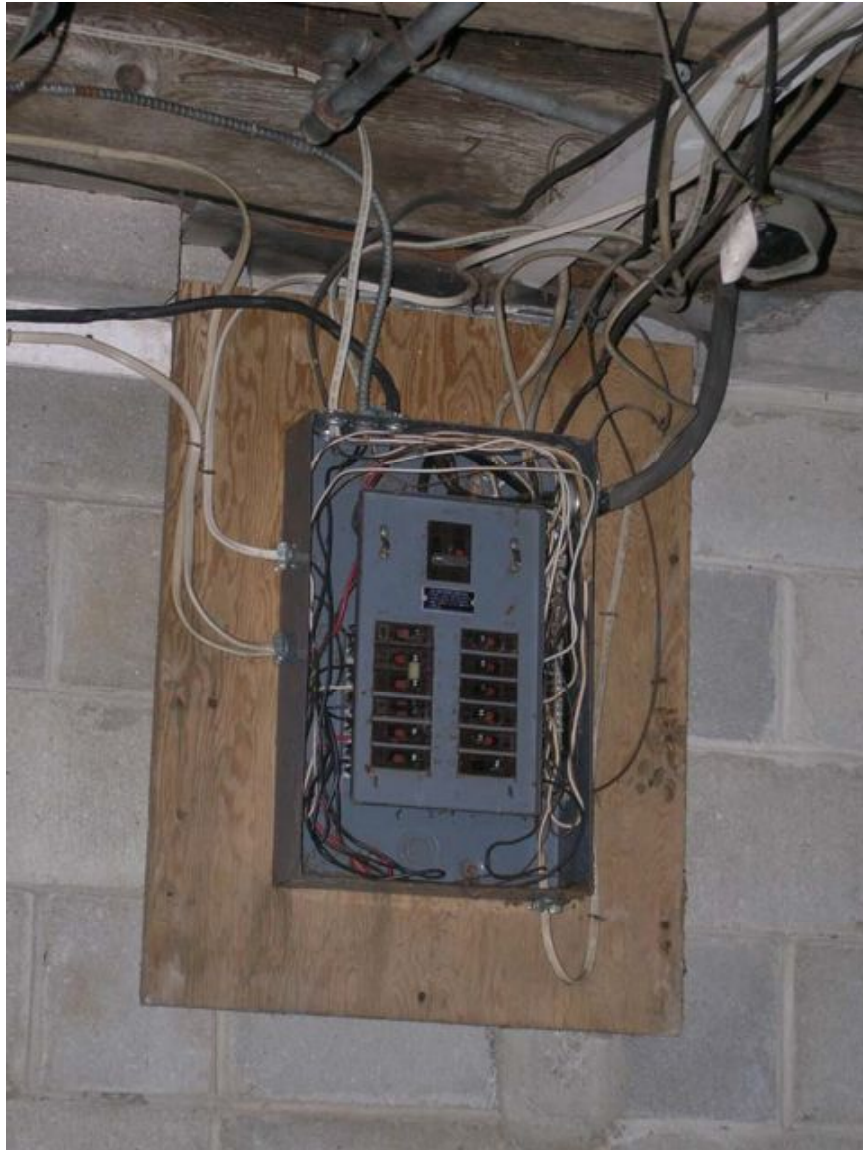
Figure 74

Electrical panel on south wall of basement.

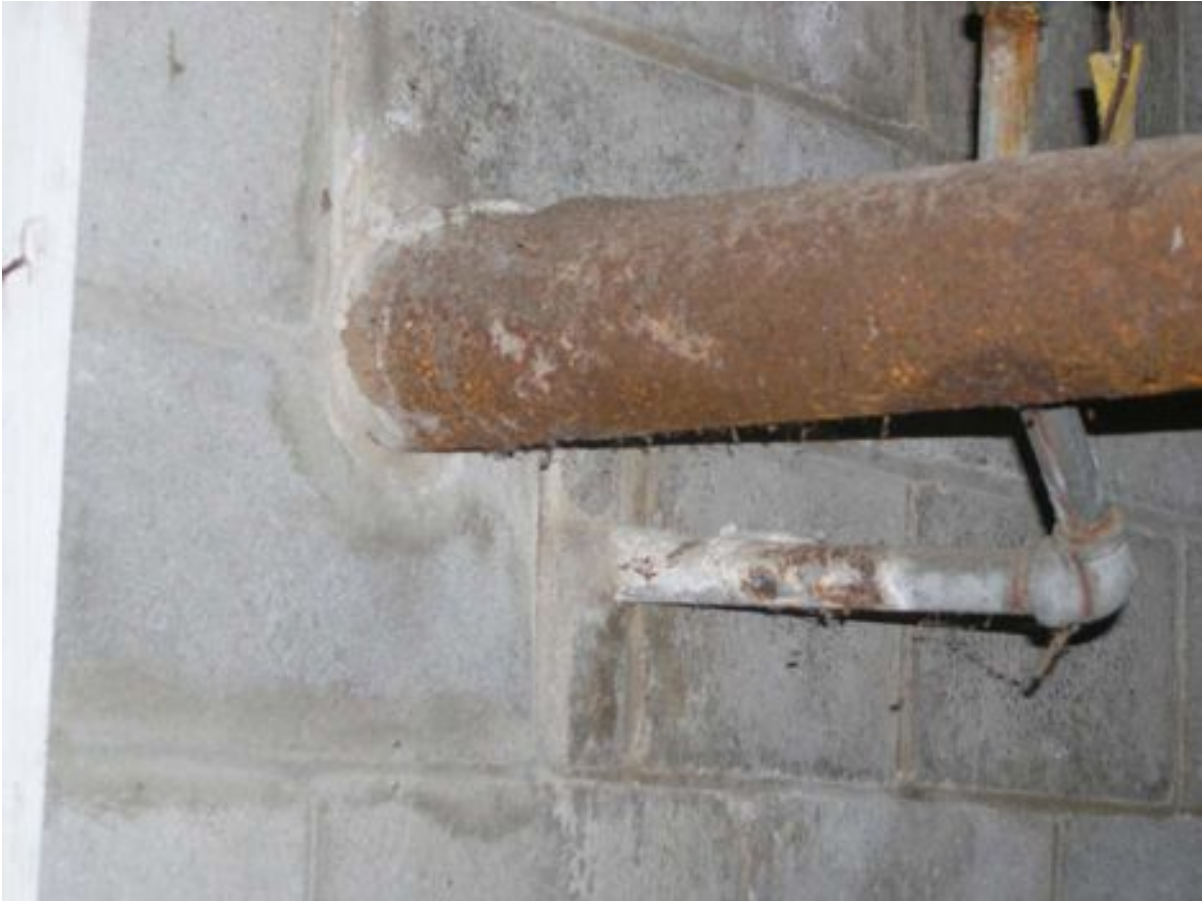
Figure 75

Corrosion on sewer and water service at penetration through west basement wall.

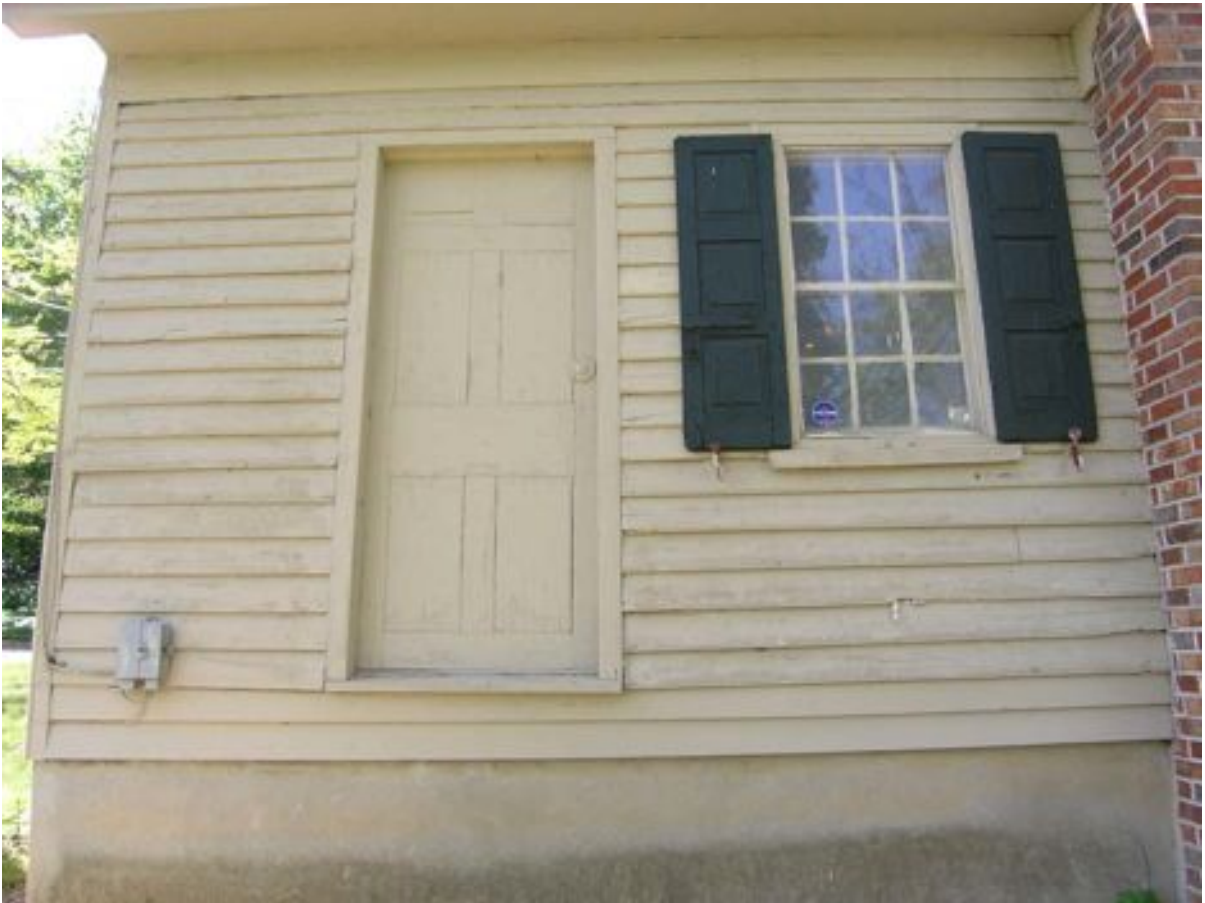
Figure 76

East door in First Build, fixed closed and covered with finishes on the interior.
