Preservation Plan

THE CUMBERLAND NAIL AND IRON COMPANY OFFICE

**MAYOR AIKEN DRIVE
BRIDGETON, NJ 08302**

**WATSON & HENRY ASSOCIATES
Bridgeton, New Jersey
Project 10-010**

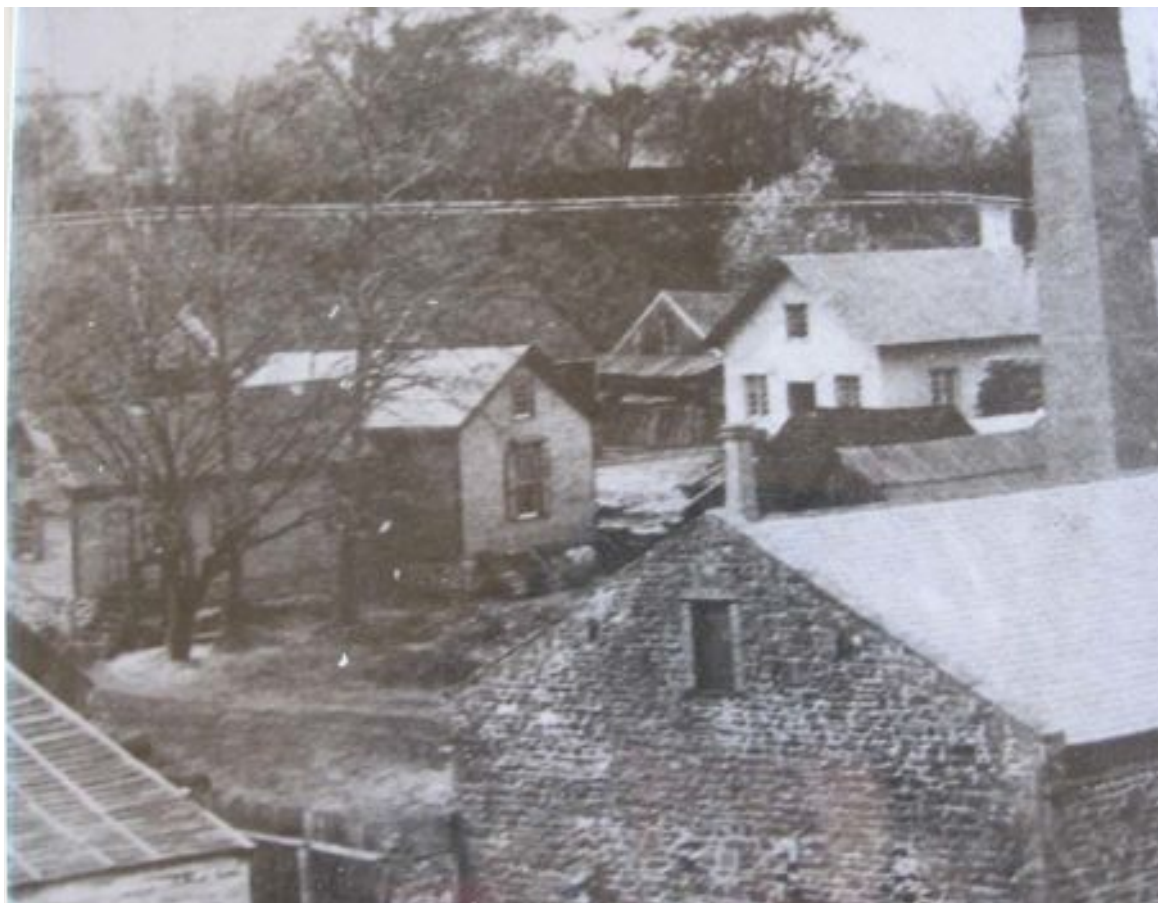
Figure 27

Only known photograph of the Cumberland Nail and Iron Company Office dating from the period when the company was operating, 1870s.

When the restroom is removed and the east exterior door made operable, the exterior steps should be rebuilt. The steps should resemble those in the historic photo (figure 27) as much as possible, while making them compliant with current building codes.

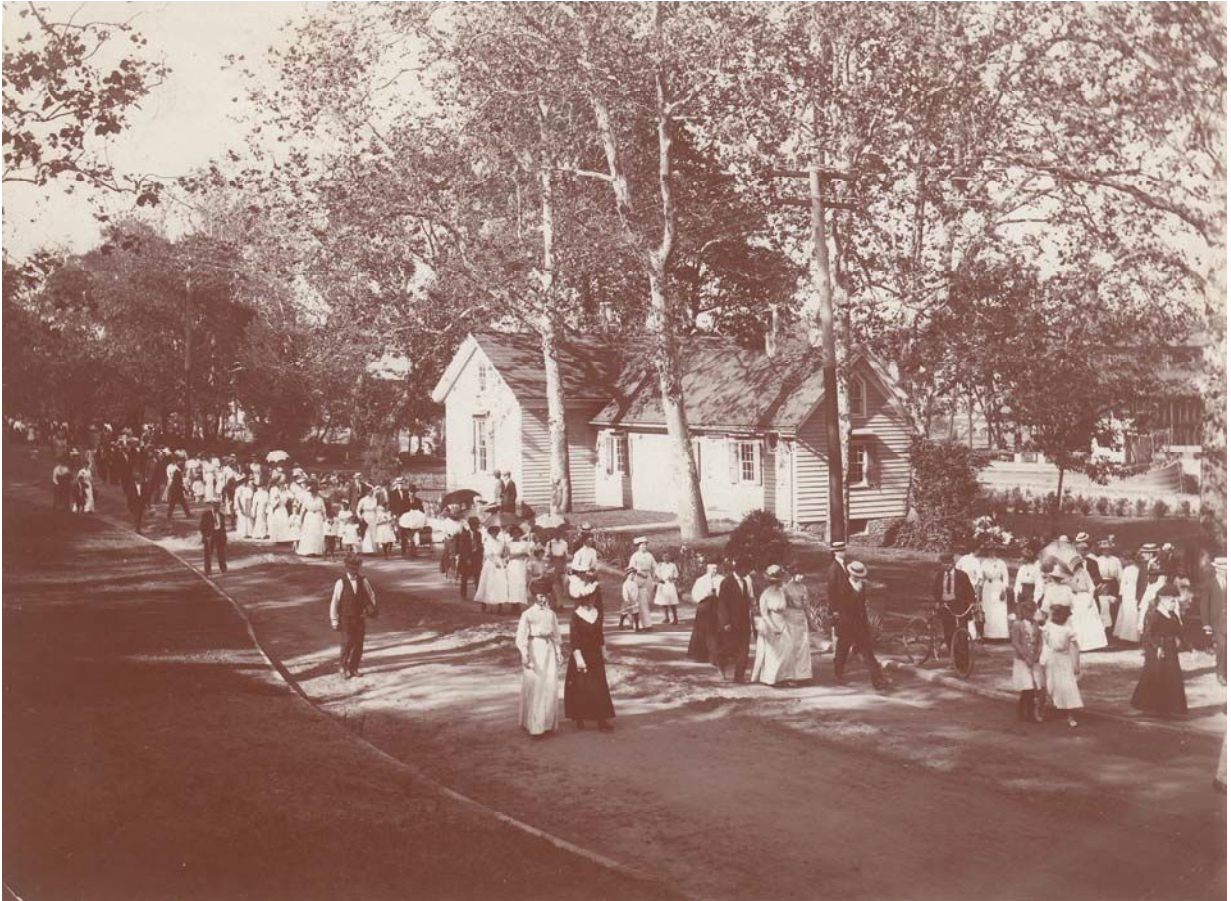
Figure 32

The Cumberland Nail and Iron Company Office does not have gutters or rainwater conductors; a historic photograph of the building at the turn of the twentieth century shows that the building did have gutters and rainwater conductors at that time (figure 32).

Cumberland Nail and Iron Company Office circa 1911, following demolition of the nail factory buildings in 1910. Note that the clock has been relocated to the west side.

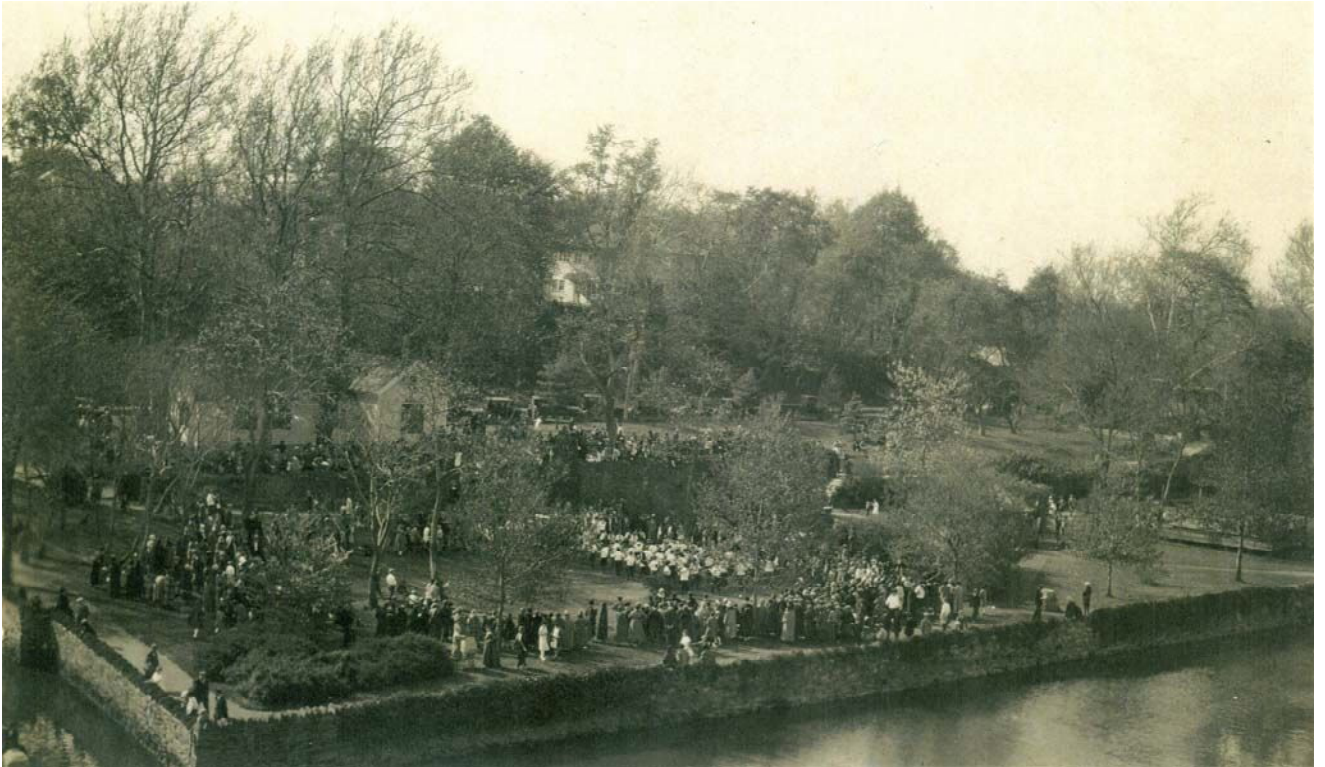
Figure 33

West bank of the Cohansey River circa 1911. Note that the steps appear to have been removed from the east door of the office.

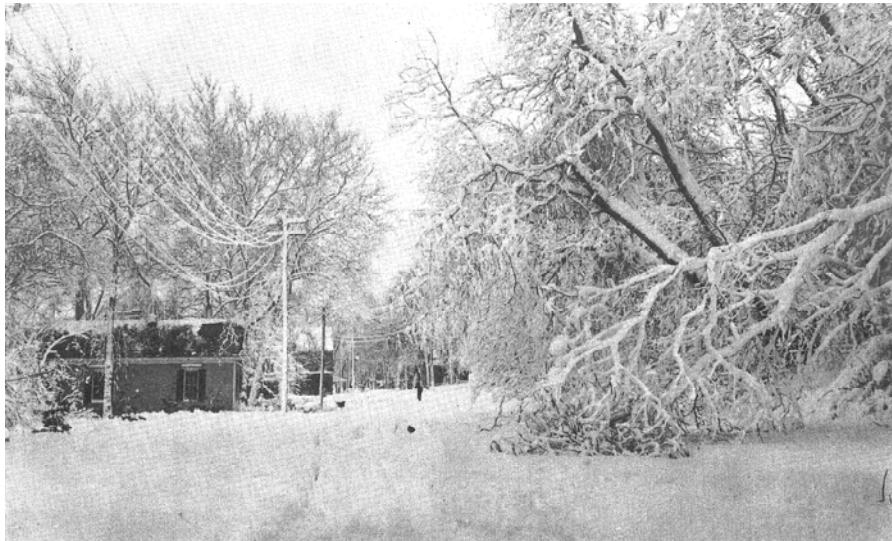
Figure 34

Cumberland Nail and Iron Company Office about 1911, looking south. Note absence of chimney on north façade.

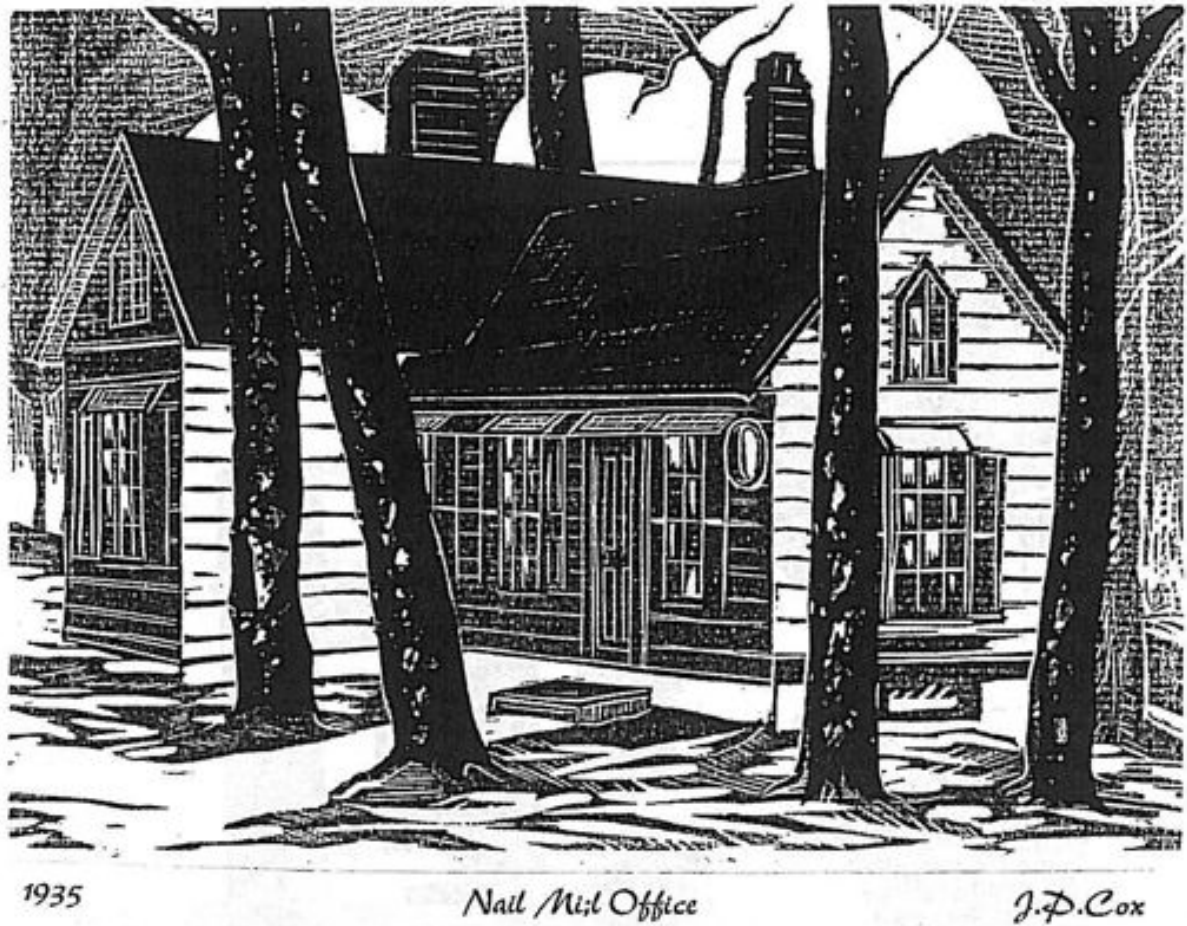
Figure 37

Linoleum print of Cumberland Nail and Iron Company Office in 1935 by James Pettit Cox. Note that chimney in south section is still extant.

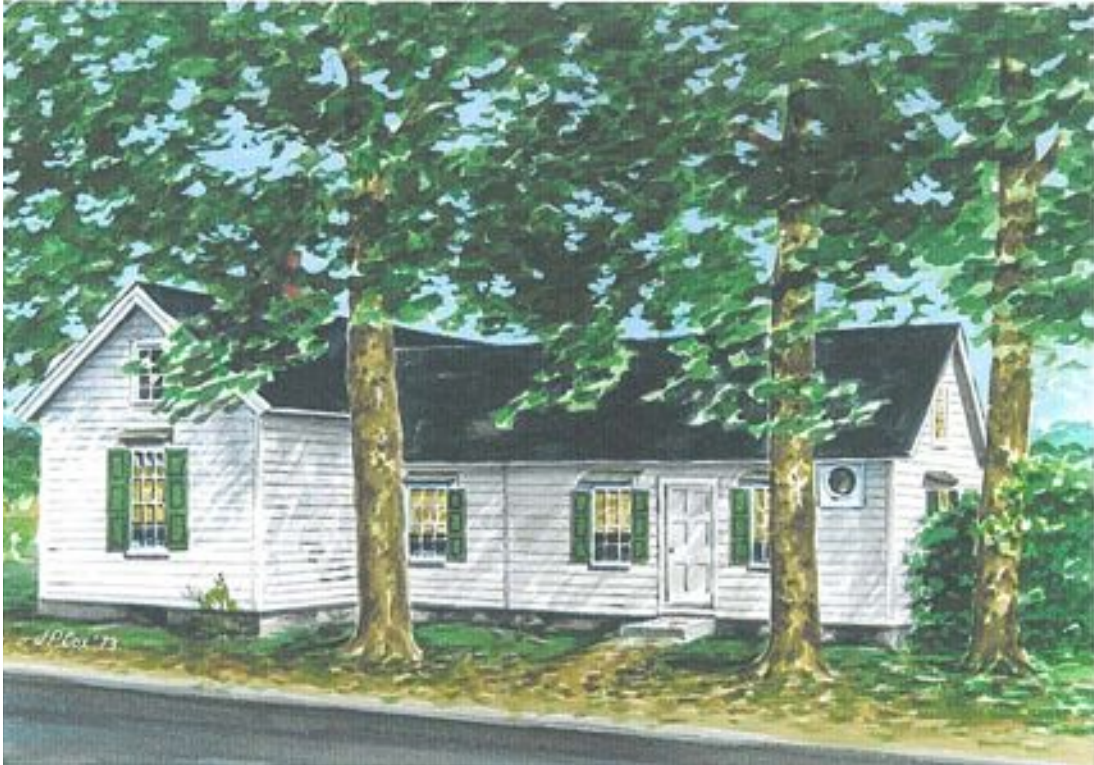
Figure 38

The foundation plantings of yews are not historically appropriate for the 1944 Period of Interpretation; there were no foundation plantings as late as 1973 (see figure 38). In addition, the yews inhibit air circulation at the base of the building and retard the evaporation of moisture. For these reasons, removal of the yews is recommended. A historically-appropriate substitute, which would provide a seasonal display, would be a border of tulips and daffodils, which were planted in the thousands at the park entrance by the city in the early twentieth century.

Illustration of Cumberland Nail and Iron Company Office in 1973 by James Pettit Cox. Note that chimney in south section has been removed, and that the window hoods are still extant.

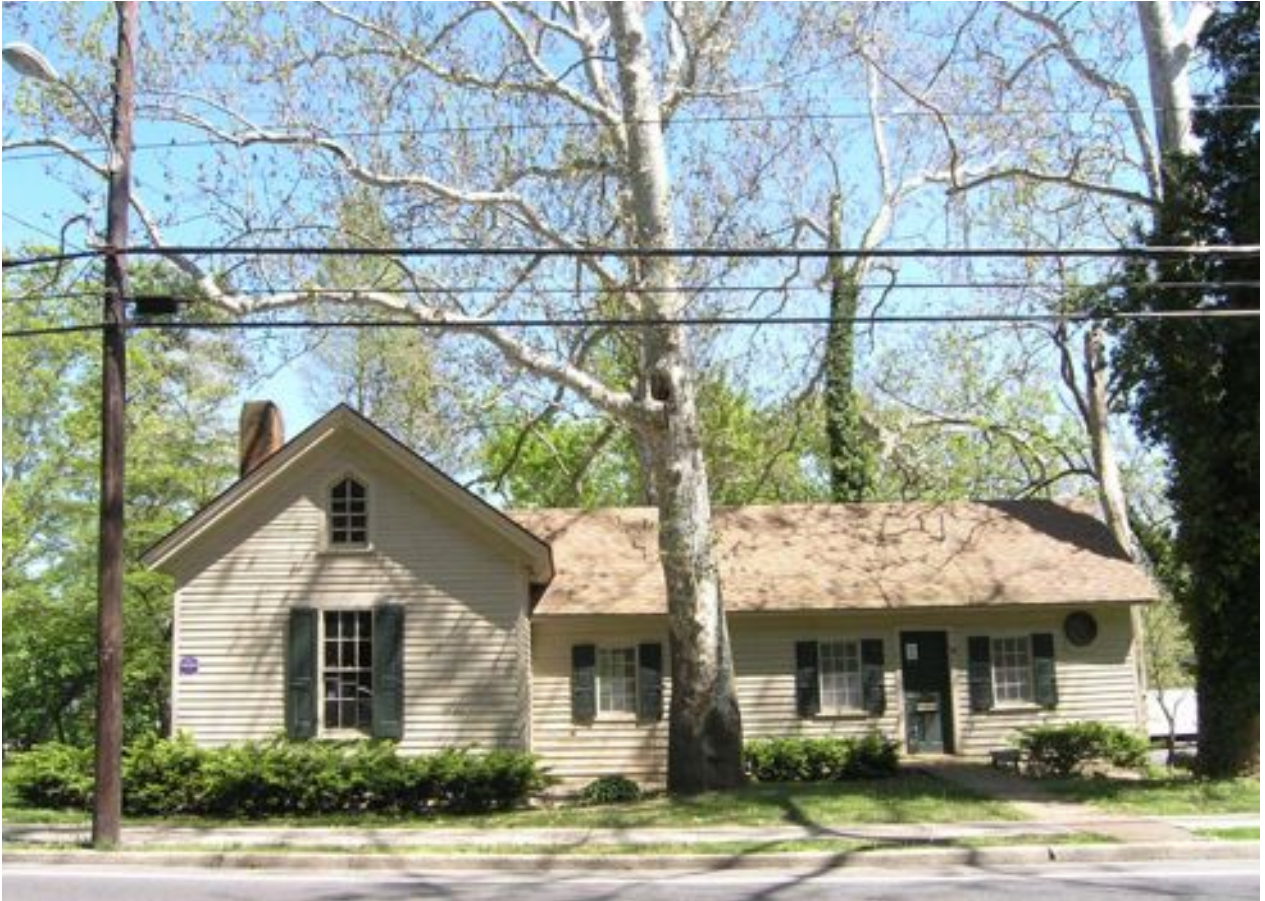
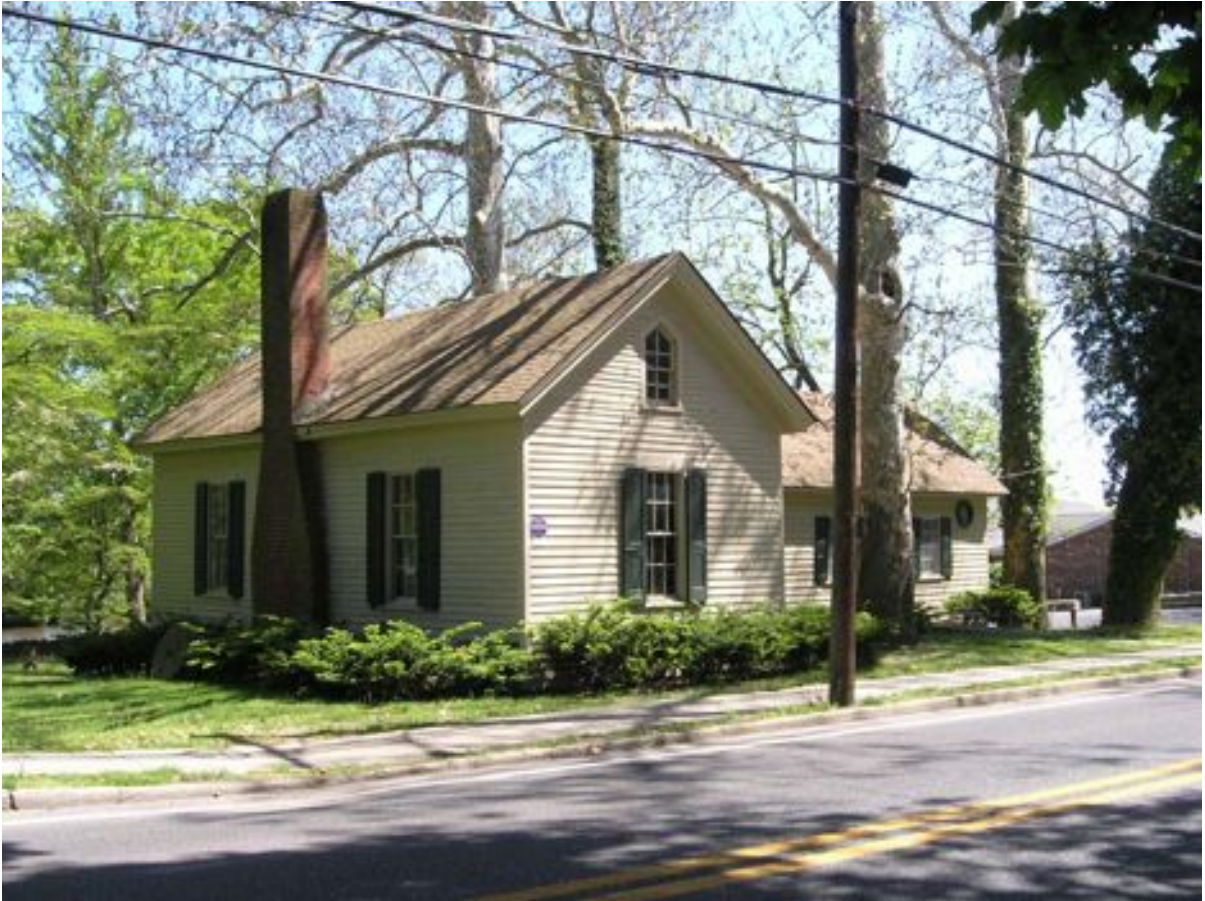
Figure 40

On the north and west sides, there are foundation plantings of yews (figures 40 and 41). The yews are healthy and attractive, but are not historically accurate (figure 32 and 38).

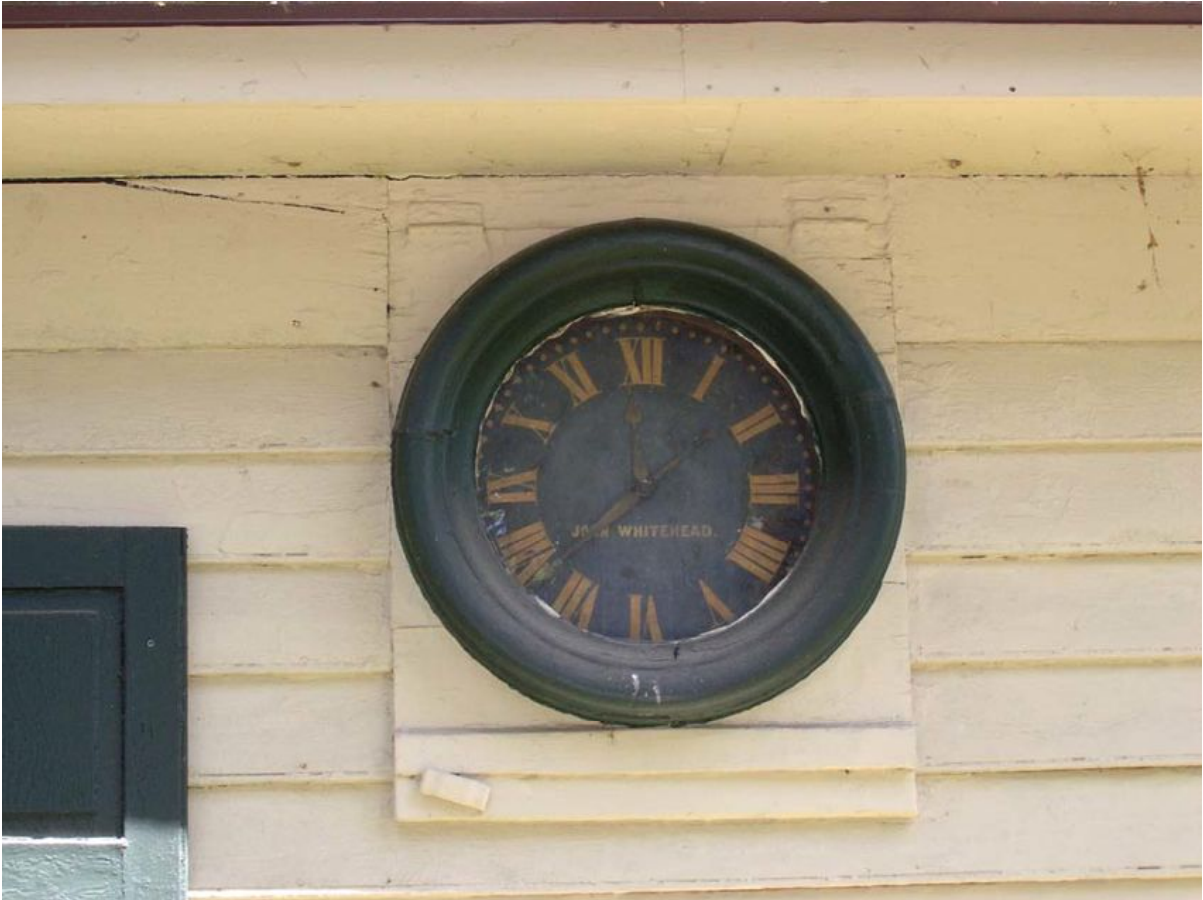
Figure 44

The clock is probably the most significant feature of the interior (figures 59 and 60), as well as the exterior (figure 44). The mechanism of the clock is currently believed to be inoperable; an analysis of the clock mechanism is beyond the scope of this report. The case of the clock on the interior was intended to imitate a tall case clock, and until well into the second half of the twentieth century, retained its historic natural finish (figure 78). The clock case has since been painted to match the wood trim in the rest of the interior (figure 59). The exterior face of the clock was intended to be accessible by means of a glazed door, hinged at the top and secured with a turn catch at the bottom; the exterior door is painted shut and is not operable.

Exterior face of double-faced clock made by John Whitehead.

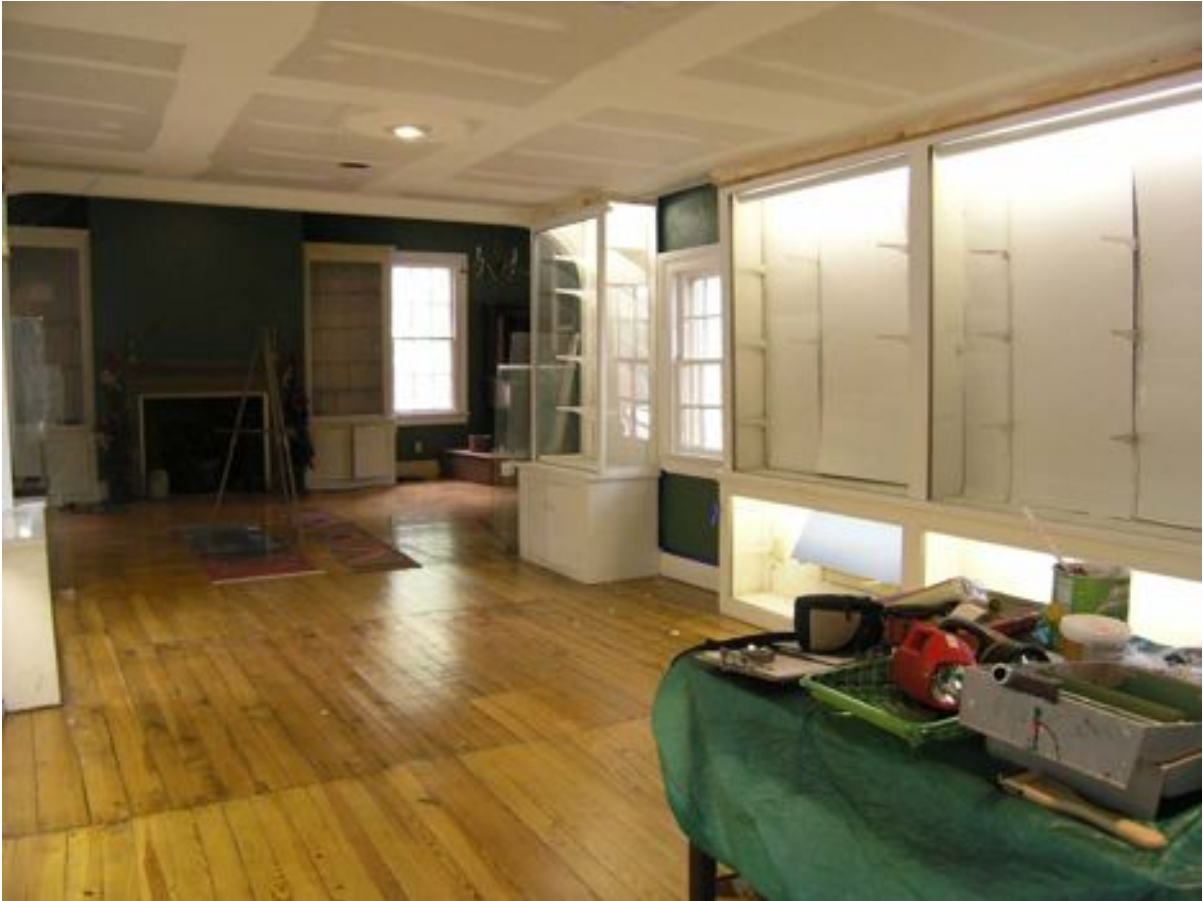
Figure 55

The walls of all three sections, and the ceiling of the north section, are plastered; the ceiling of the south and center sections is gypsum wallboard, and was installed in the early twenty-first century (figure 55). Where visible, the plaster appears to be intact, with only minor cracks; a large percentage of the wall area is covered with exhibit cases.

Interior looking northeast. Note change in floorboards in foreground marking juncture of First and Second Builds (south and center sections).

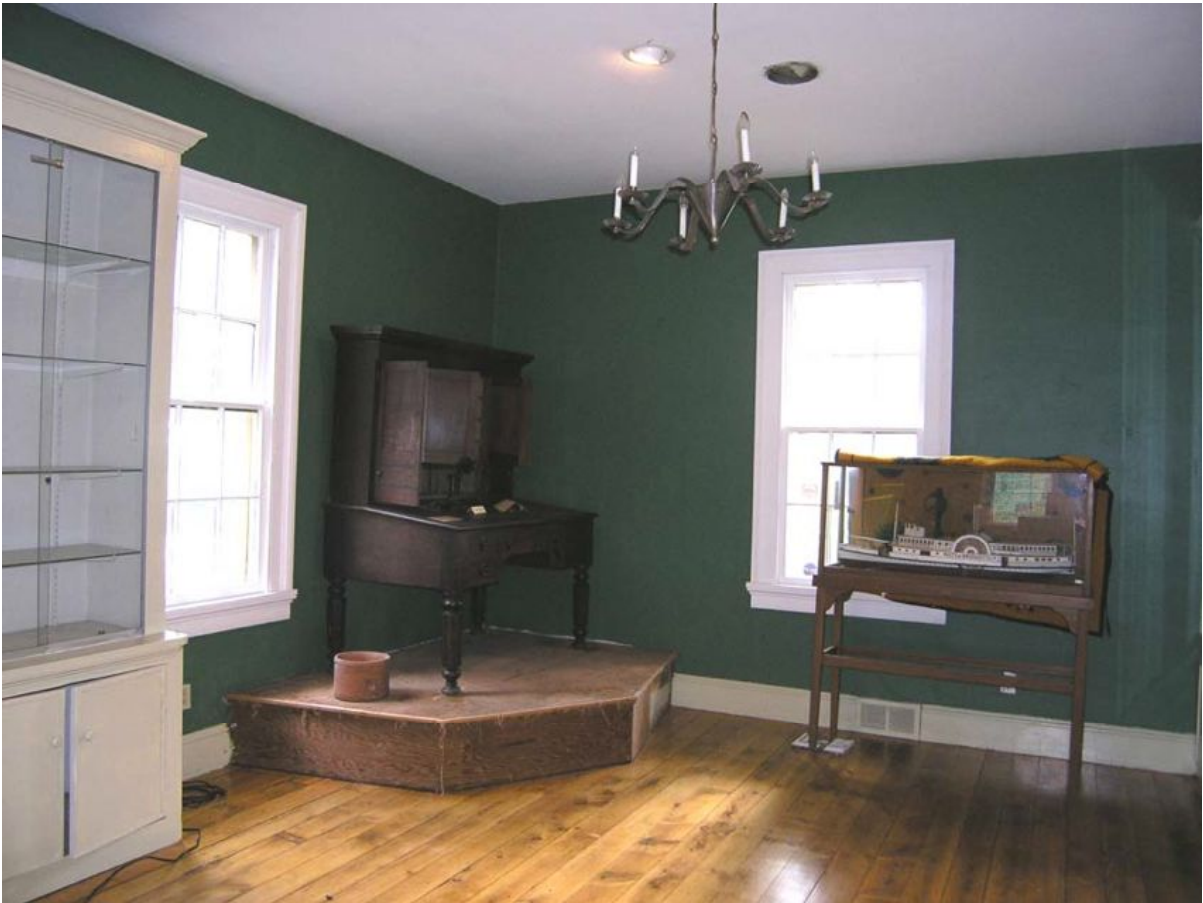
Figure 56

Lighting in the main room consists of three downlights in the ceiling of the south and center section, with two more holes cut where lights have not been installed; three aimable floodlights in the ceiling of the north section, and, also in the north section, two chandeliers with candle lamps (figures 55 and 56).

Interior of Third Build (north section) looking northeast.

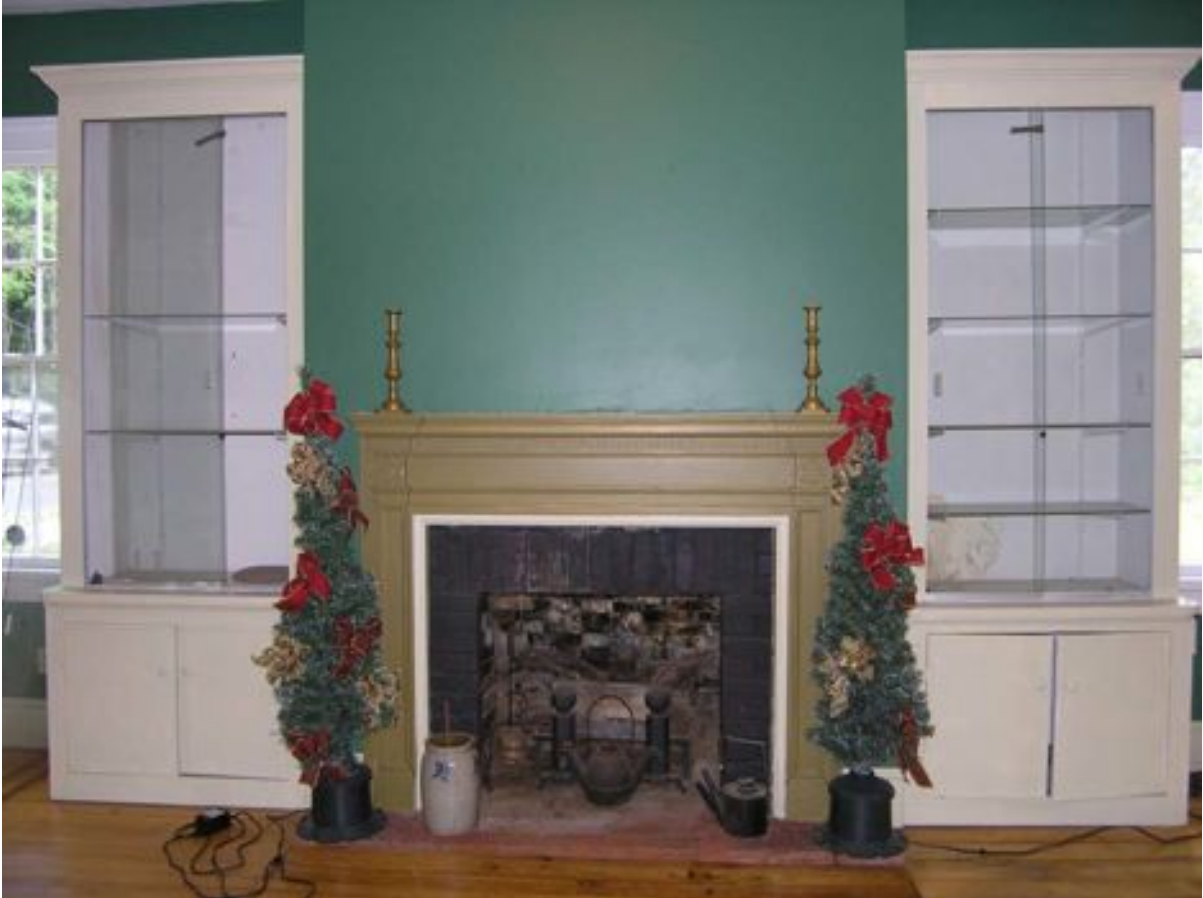
Figure 58

The brick fireplace with federal-style mantle that dates to 1944 shows no signs of deterioration (figure 58).

Fireplace added by City of Bridgeton circa 1944.

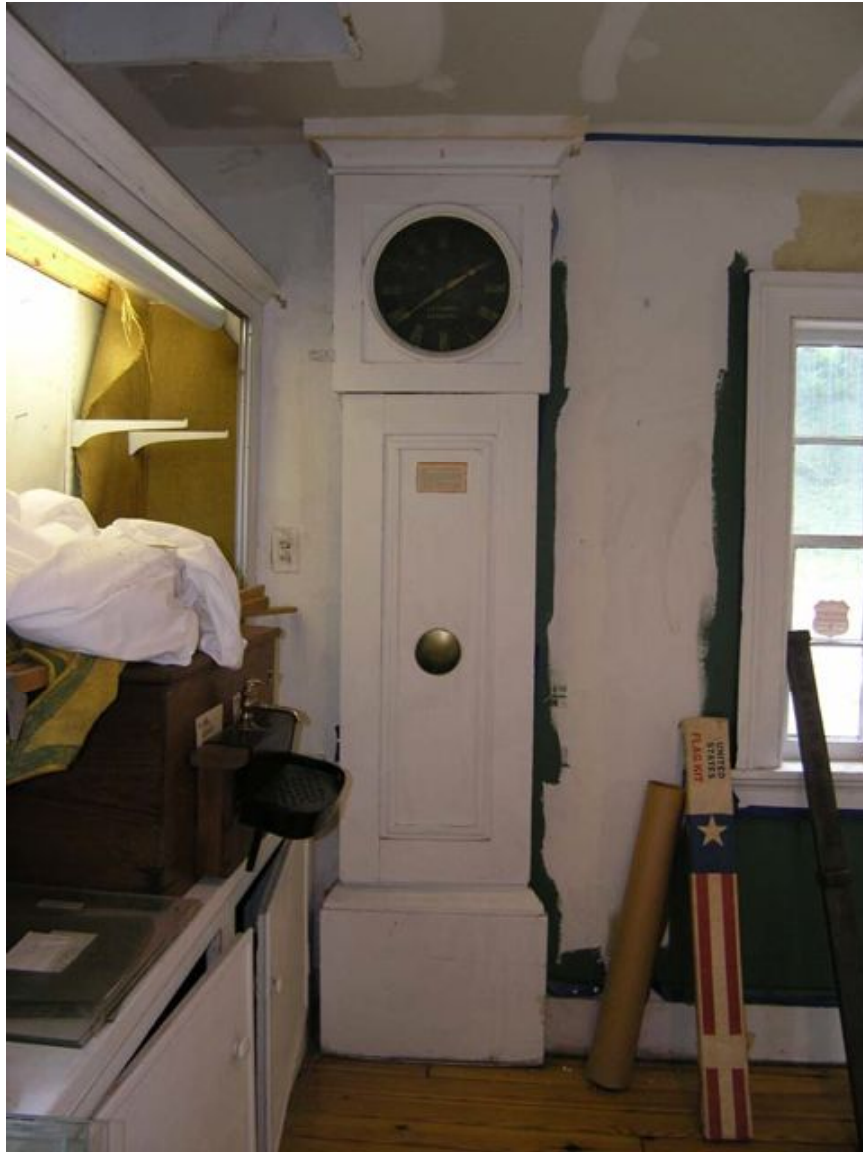
Figure 59

Double-faced clock from interior.

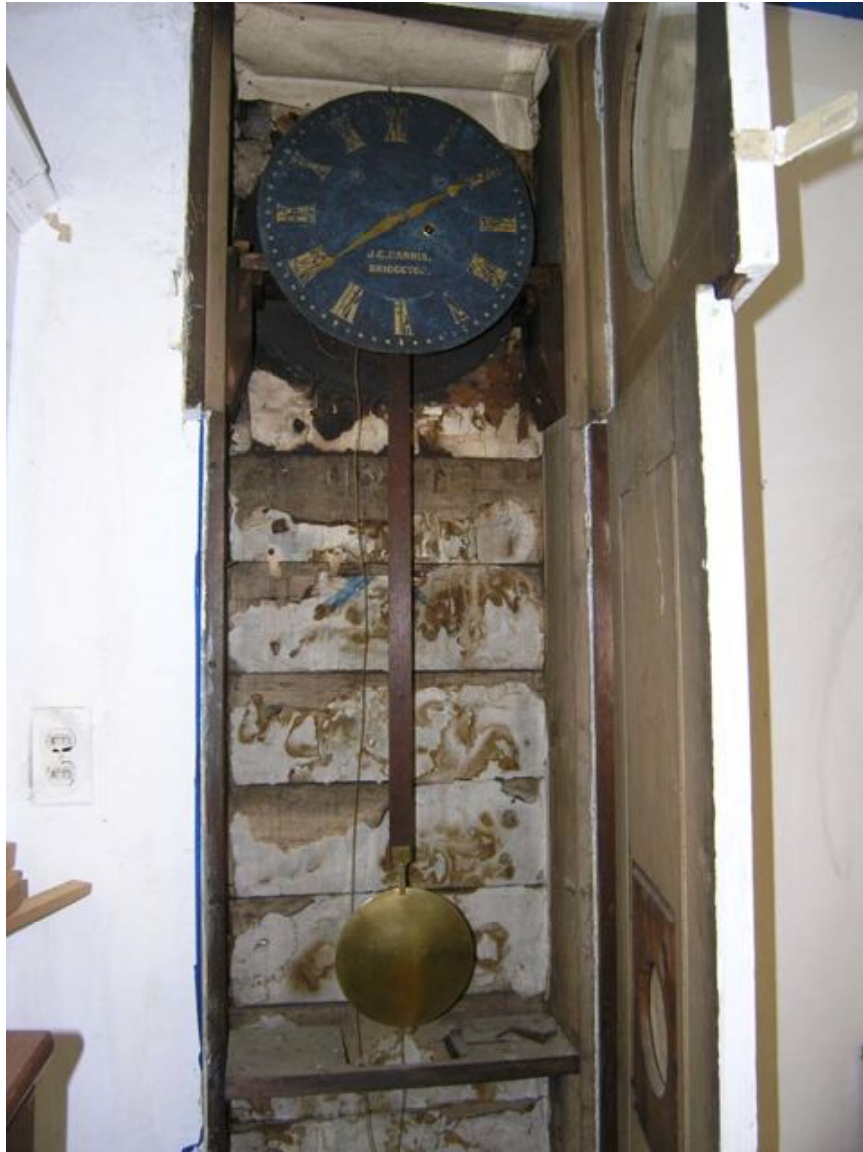
Figure 60

Clock interior.

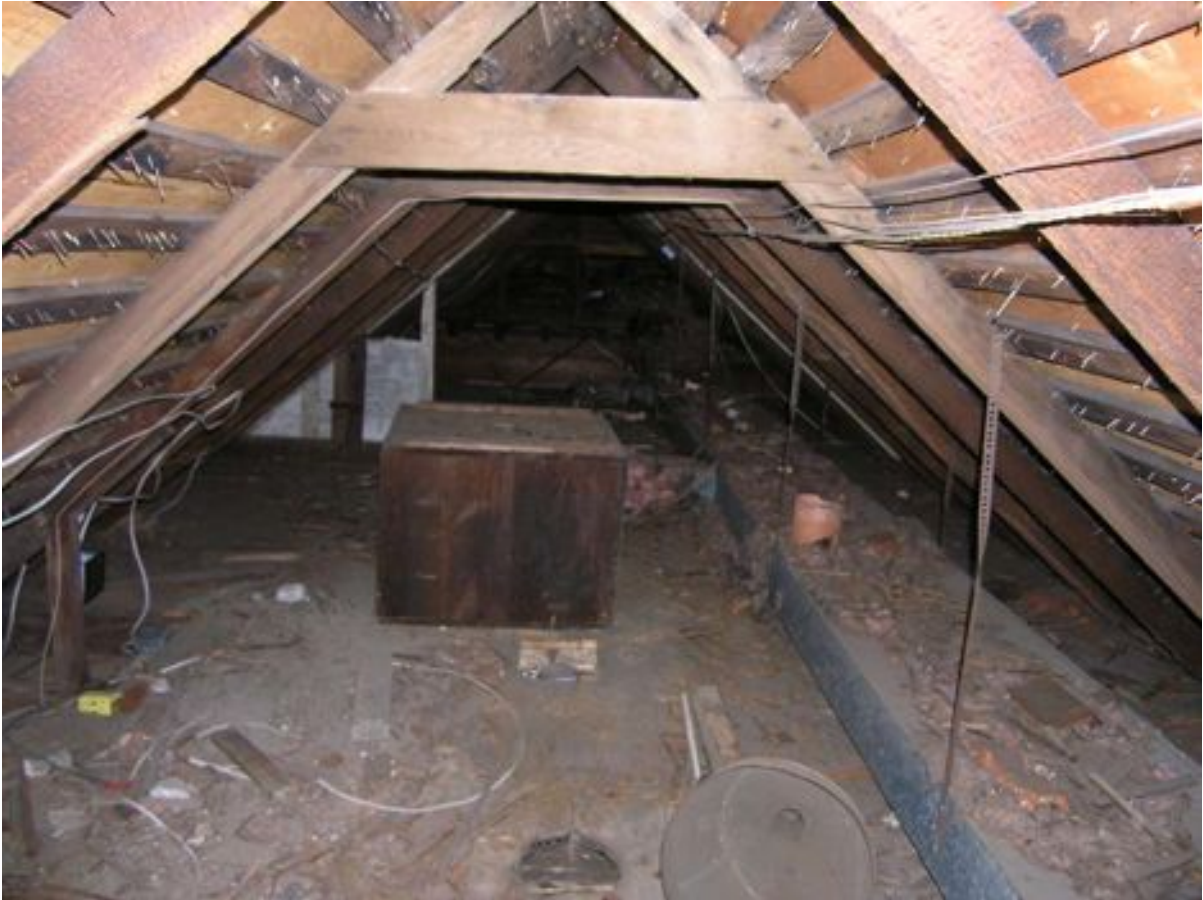
Figure 63

The attic, which originally was accessible by means of a stair in the southwest corner of the south section, where the hatch now is, was occupied space, though probably used primarily for storage (figures 63 and 65). The south section originally had brick nogging between the studs in the gable ends, with a beaded baseboard at the base of the wall; the nogging was whitewashed. The entire attic is floored.

Attic of First Build (south section) looking north.

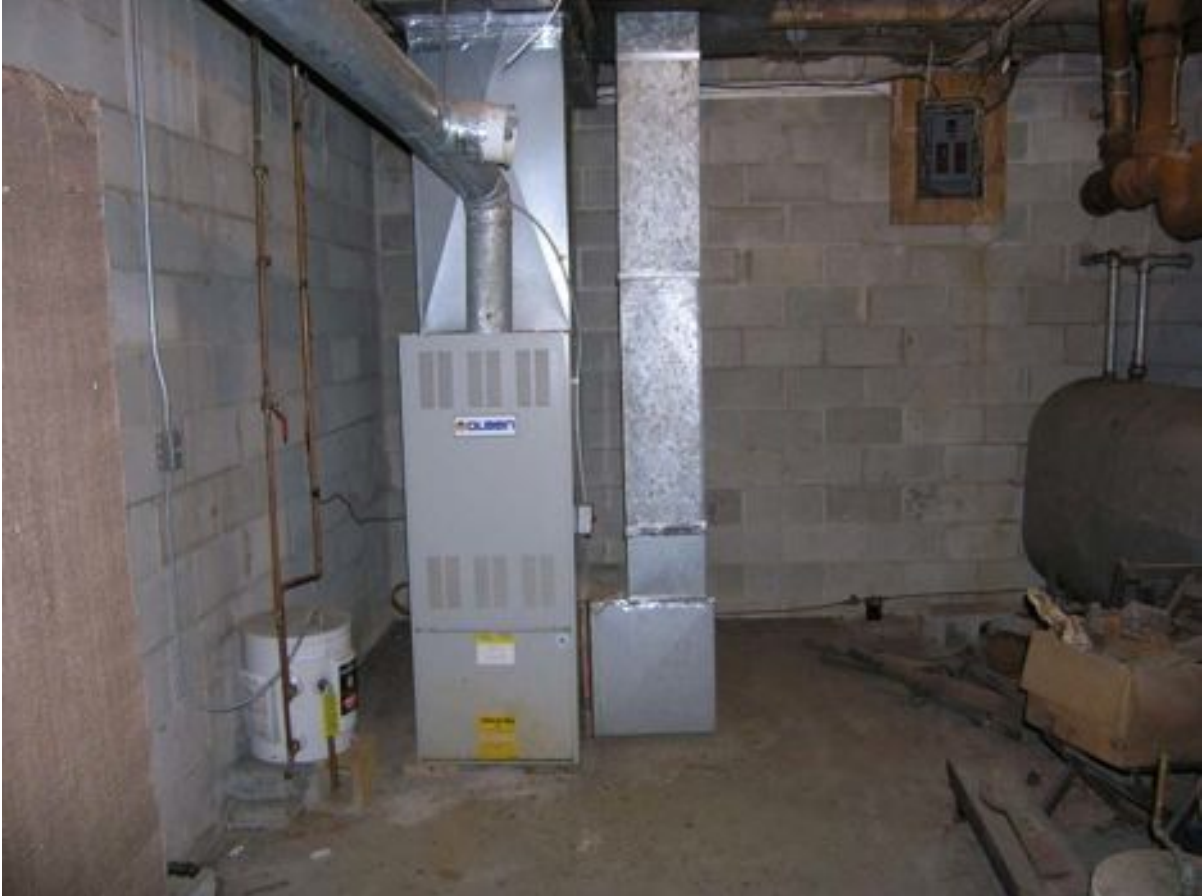
Figure 72

Heat is provided by an oil-fired, up-flow warm-air Olsen furnace (figure 72). The filter has not been cleaned or changed, and it appears the furnace is not being maintained. The flue pipe for the furnace is perforated.

Electrical service is 100 Ampere, single phase, entering the building at the south end. The electrical panel box is located on the south wall of the basement, near the ceiling; it is too high to be accessible without a ladder (figure 72). The cover is missing from the panel box. Electrical wiring is non-metallic sheathed (NMS).

Warm air furnace in southeast corner of basement.

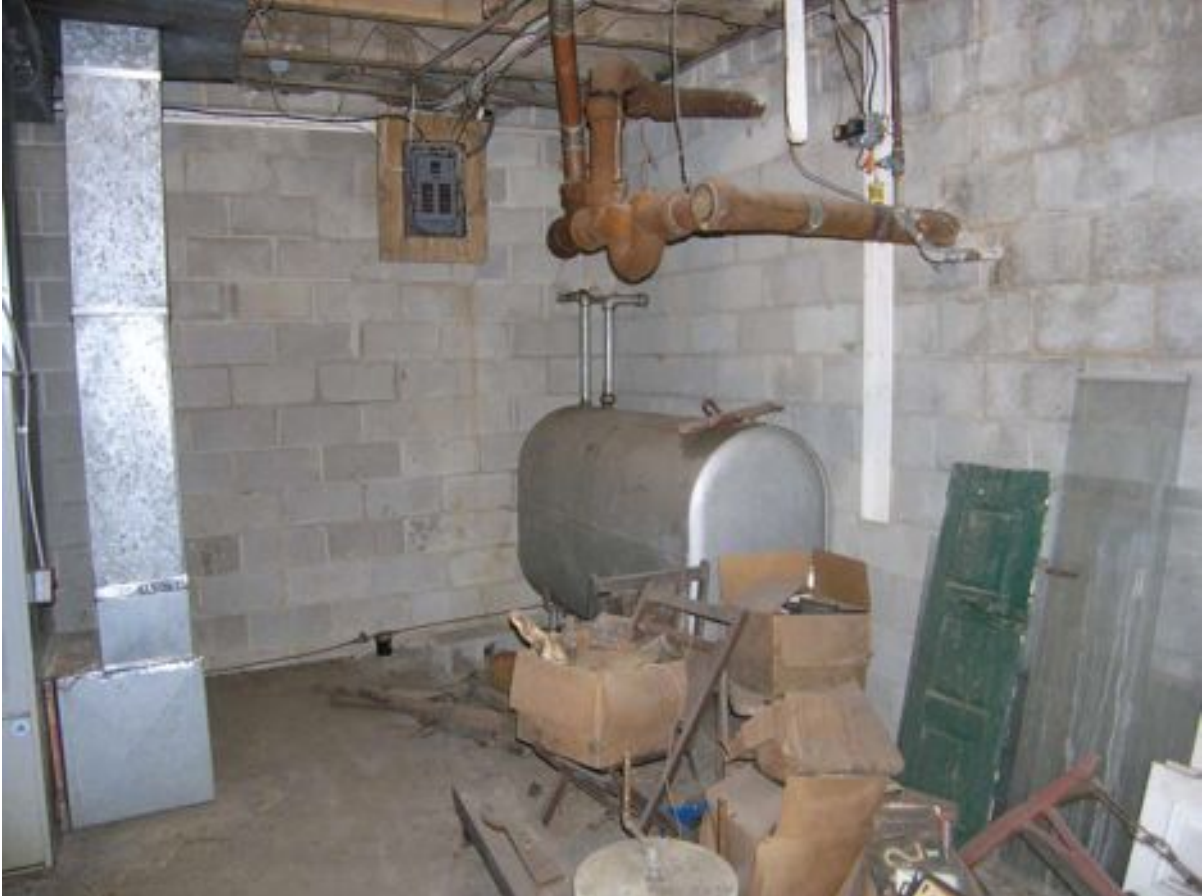
Figure 73

- A restroom in the southeast corner of the first floor with toilet and lavatory;
- Assumed connection to municipal sewer, exiting the basement through the south end of the west wall (figure 73);
- Assumed connection to municipal water, entering the basement through the south end of the west wall;
- A hose bibb on the south exterior foundation wall.

Fuel storage tank, electrical panel and sewer and water connection in southwest corner of basement.
